**College of Health and Medical
Technologies
Department of Radiology
Technologies
Computed Tomography**

CT ARTIFACTS

LECTUER 8

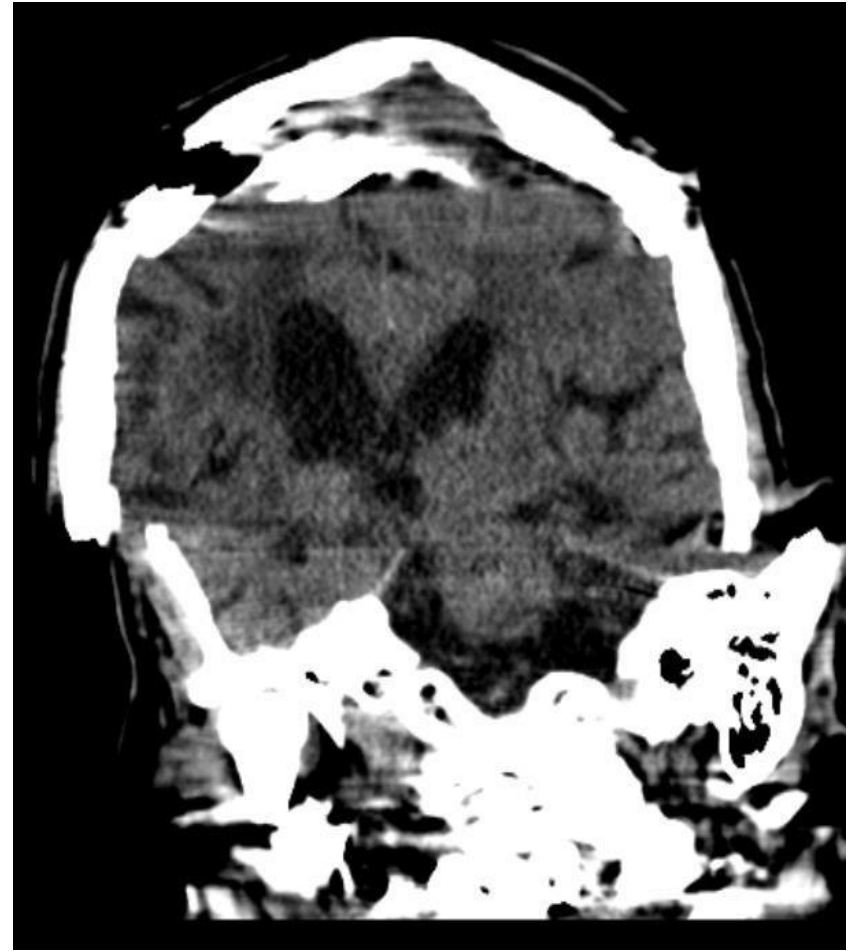
Misregistration artifacts, which appear as blurring, streaking, or shading, are caused by patient movement during a CT scan. Blurring also occurs with patient movement during radiographic examinations.

Involuntary motion, such as respiration or cardiac motion, may cause artifacts that mimic pathology in surrounding structures. Techniques, such as cardiac gating, may be used for examinations that concern the mediastinum

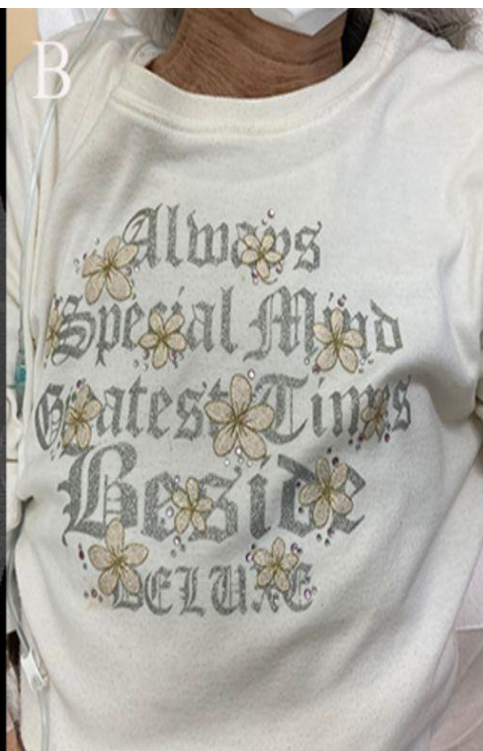
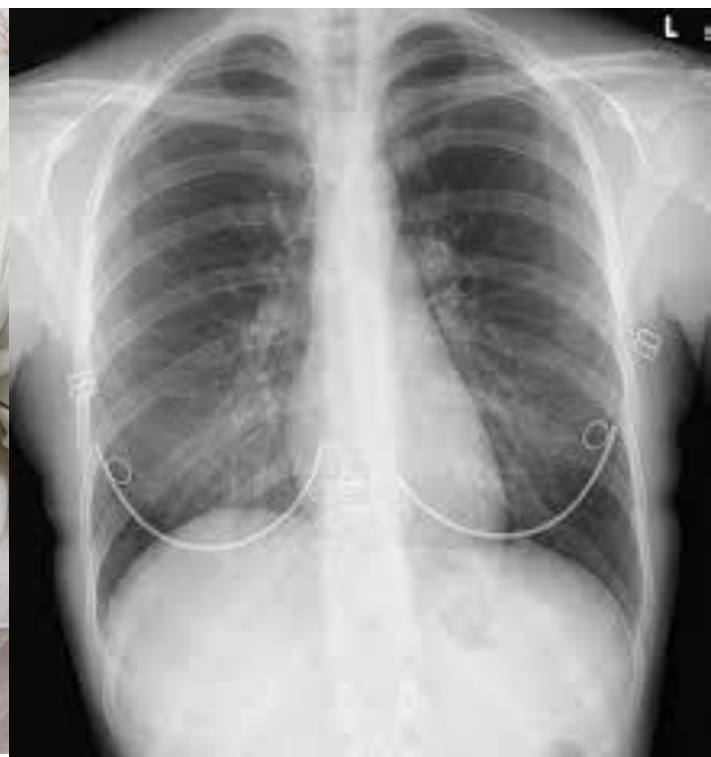
Clothing artifacts

Clothing artifacts, like [jewelry artifacts](#), are a regular feature on imaging examinations, especially [plain radiographs](#), but in general are recognized for what they are, either at the time the image is taken by the radiographer, or later by the reporting radiologist. The radiographer will often either retake the image or more commonly they will label the image with a warning that clothing artifact is present to avoid any misinterpretation taking place.

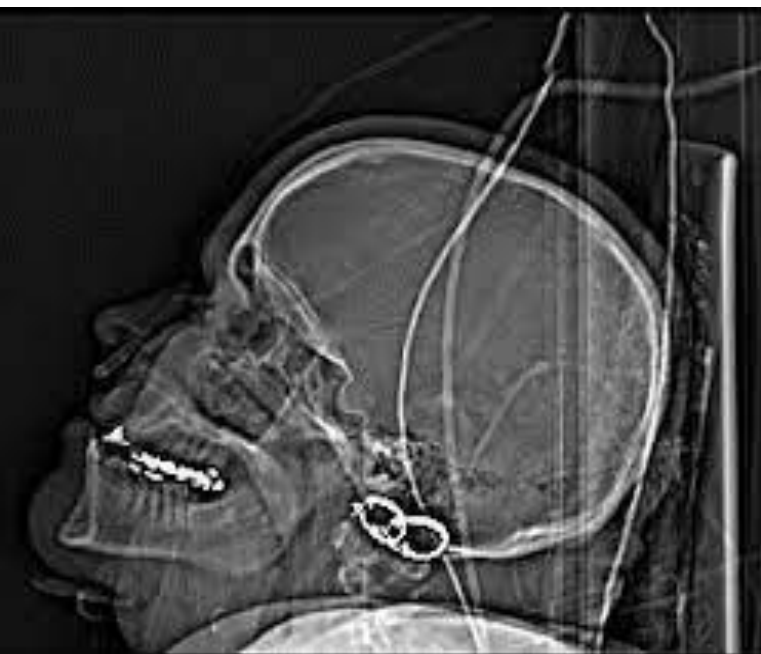
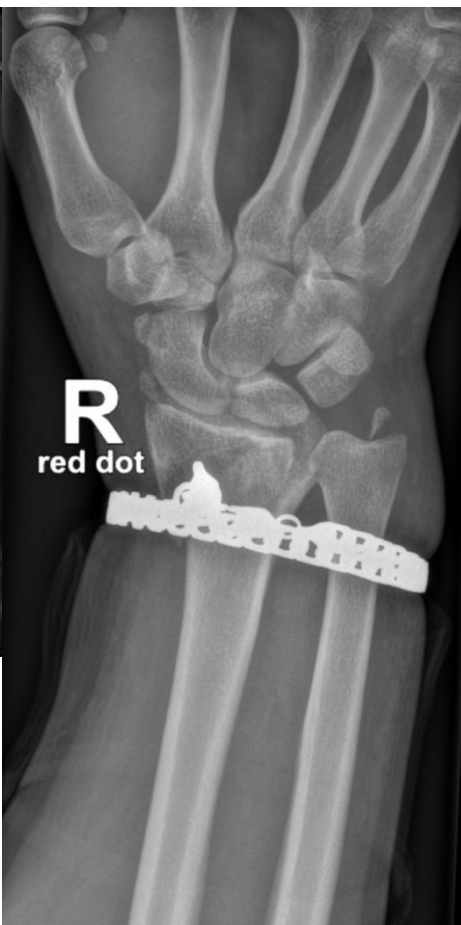
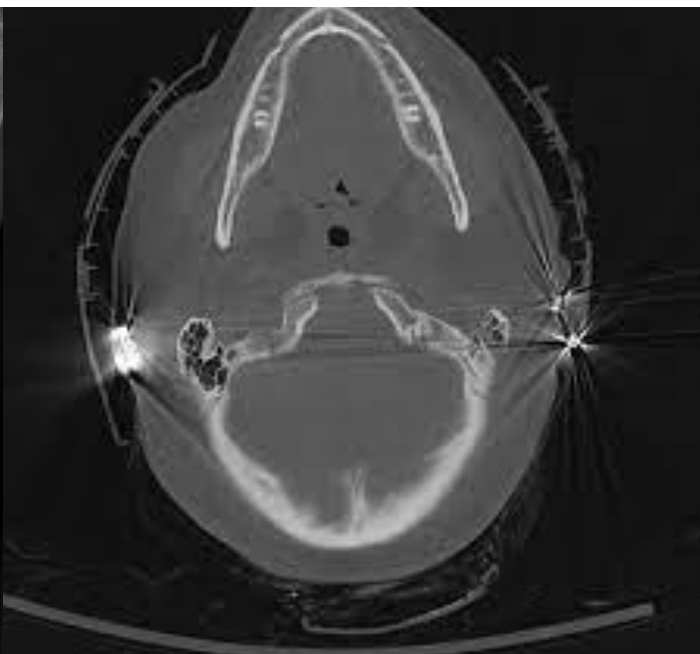
jewelry artifacts

It is common to see **jewelry artifacts** on imaging examinations, most commonly [plain radiographs](#), although also on other [modalities](#), where they can produce unhelpful [artifacts](#) that may obscure important structures and preclude confident diagnostic evaluation

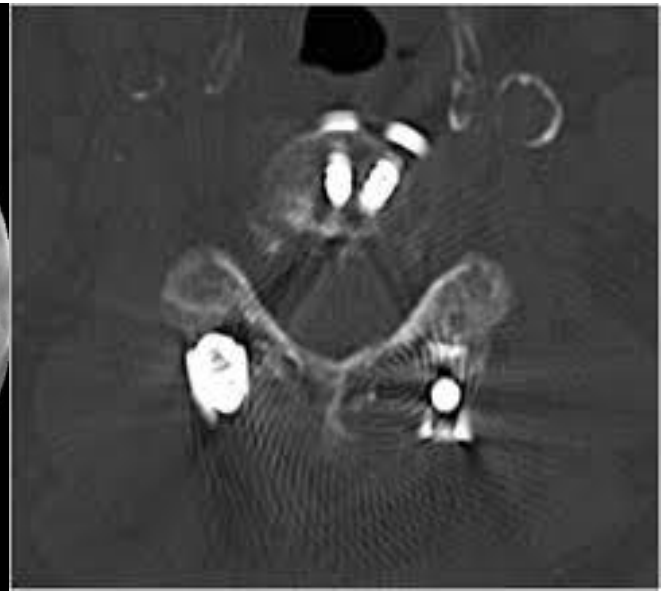
Streaking artifact appears as multiple dark streaking bands positioned between two dense objects, for example at the posterior fossa. Streaking may also occur along the long axis of a single high attenuation object. It is the result of the polychromatic x-ray being 'hardened' at different rates according to rotational position of the tube/detector.

Shading from missing data in shadow of biopsy needle.

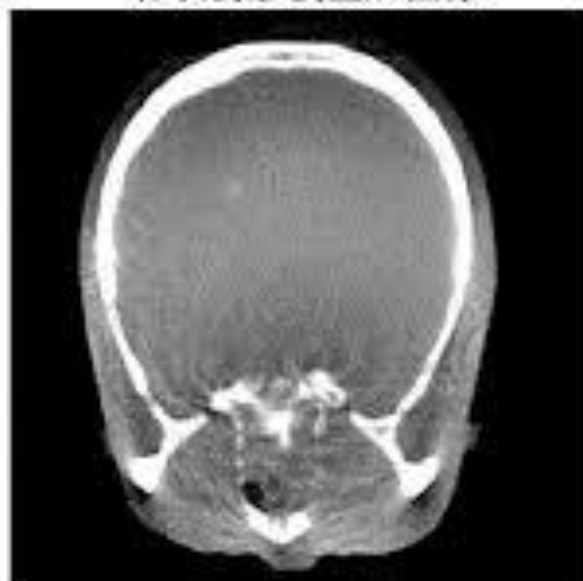
原始图像

杯状伪影校正后图像

Beam hardening will cause the middle of the image to decrease in value, not increase edge value, as the lower energy photons preferentially get attenuated over longer path lengths. As the beam becomes harder and passes a higher mean beam energy, the lower [attenuation coefficient](#) means the CT number goes down for longer paths.

Since simple beam hardening correction is built into modern scanners, cupping artifact is not usually encountered during clinical imaging. The characteristic "cupped shaped profile" of the CT numbers is best demonstrated when scanning [phantoms](#)

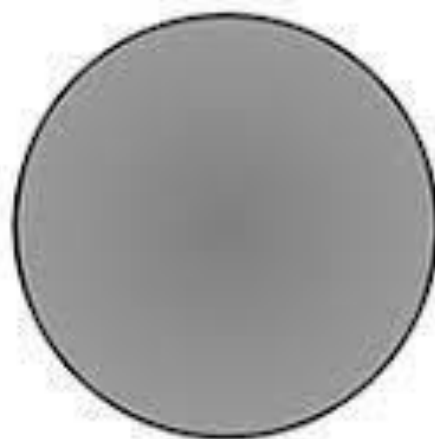
Cupping artefact

Uncorrected

Corrected

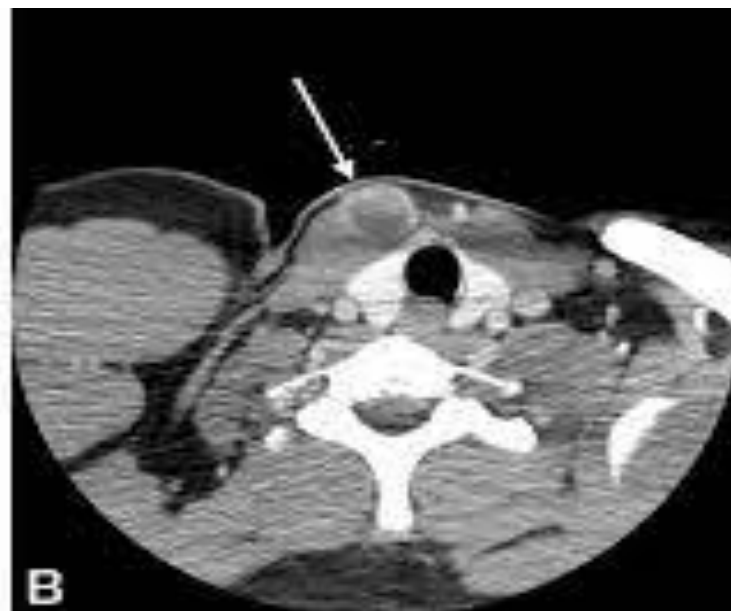
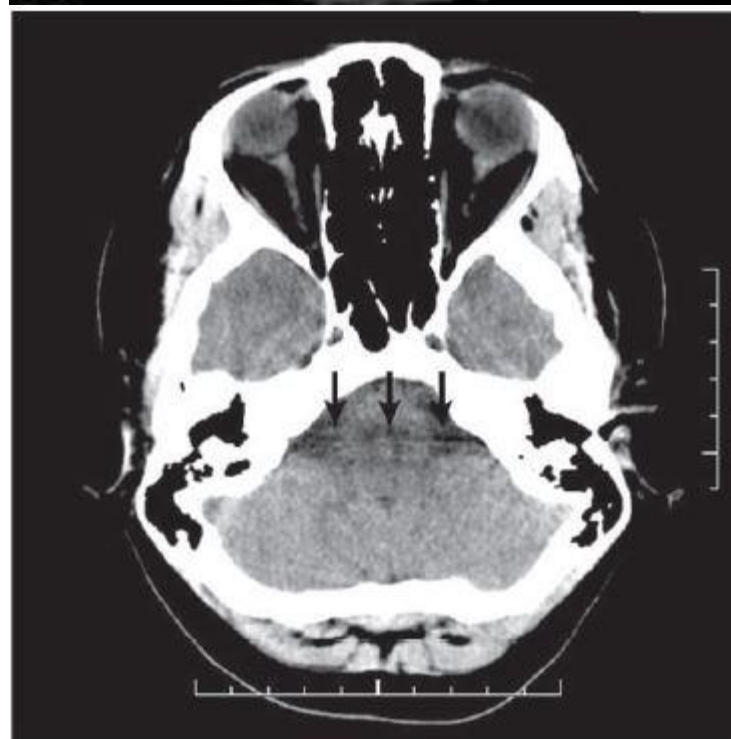
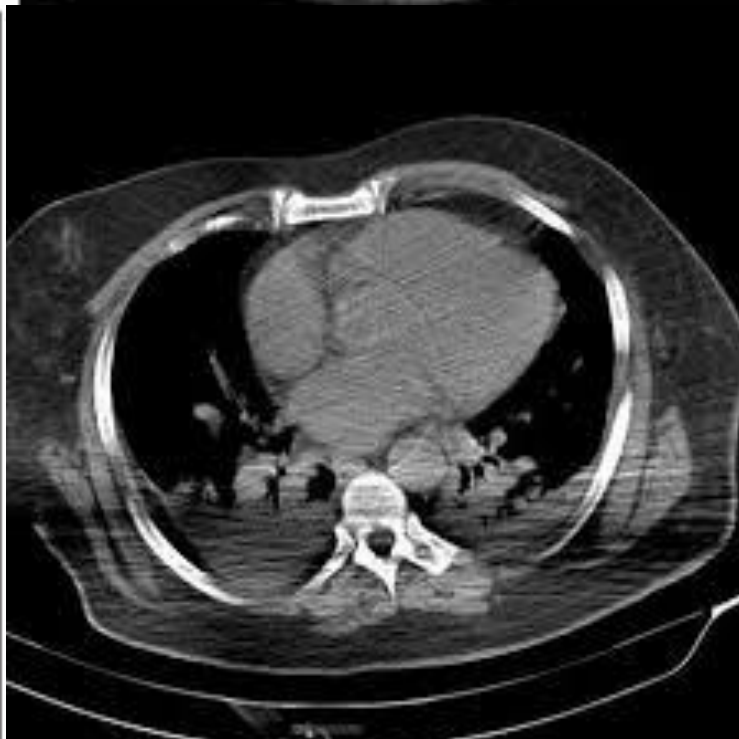
Beam hardening

is the phenomenon that occurs when an x-ray beam comprised of polychromatic energies passes through an object, resulting in selective attenuation of lower energy photons. The effect is conceptually similar to a high-pass filter, in that only higher energy photons are left to contribute to the beam and thus the mean beam energy is increased ("hardened")

CT beam hardening artifact has two distinct manifestations, streaking (dark bands) and cupping artifacts.

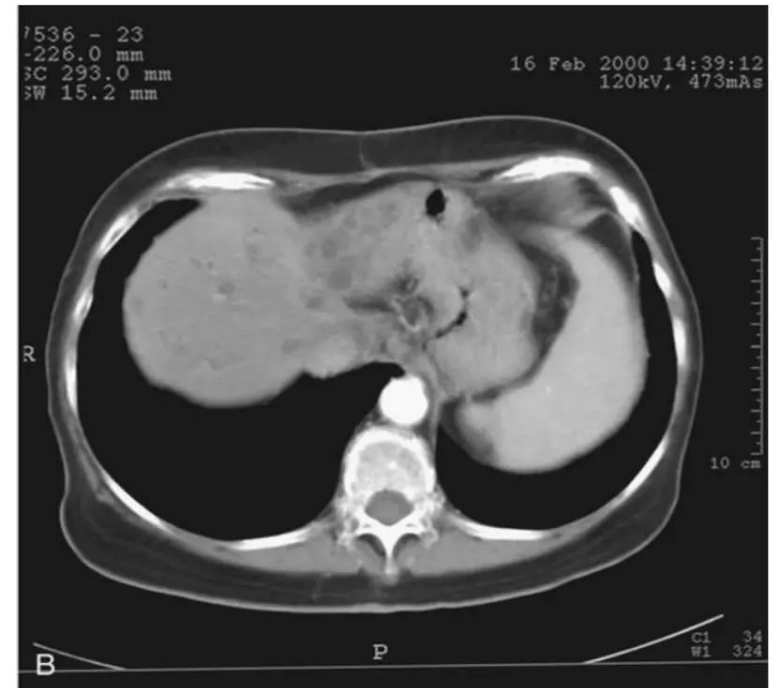
PARTIAL VOLUME ARTEFACT

Liver scan showing partial-volume artifact. A, A 2.5-mm slice thickness shows good visibility of small liver lesions. B, A 10-mm slice thickness shows reduced lesion detectability with partial-volume averaging. (Images courtesy Dr. John Haaga.)

occurs when tissues of widely different absorption are encompassed on the same CT [voxel](#) producing a beam attenuation proportional to the average value of these tissues.

Partial volume averaging is particularly problematic in CT angiography (e.g. misdiagnosis of an apparent contrast filling defect caused by the artifact as pulmonary embolism PE). Therefore the use of thin section reconstructions (1-1.5 mm) are recommended where the impact of this artifact is negligible

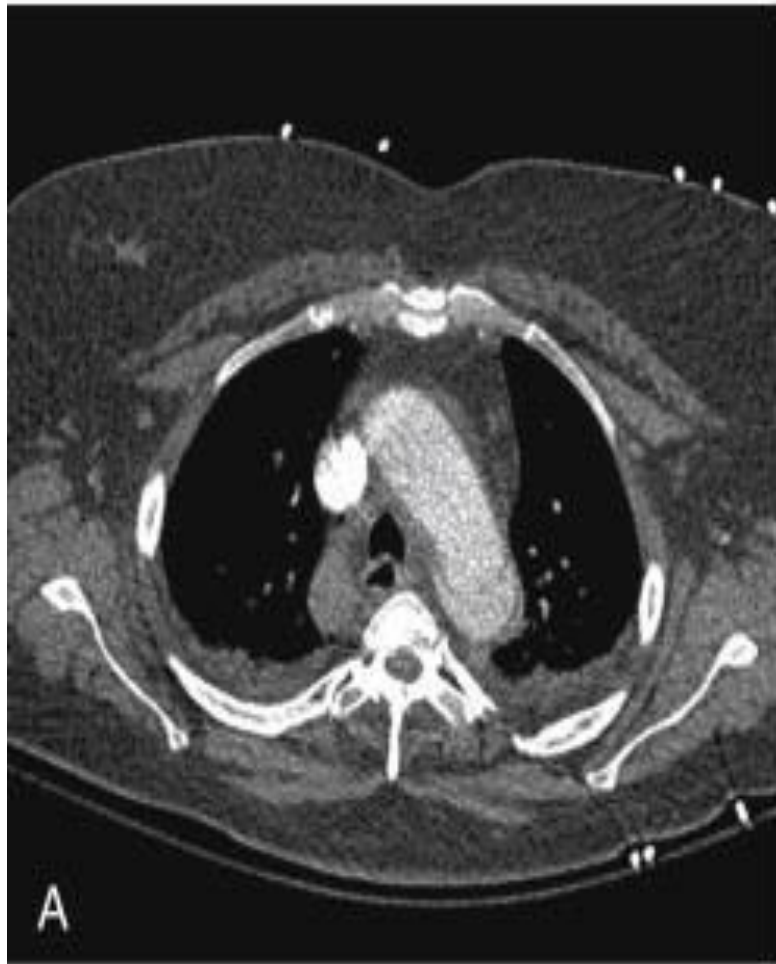
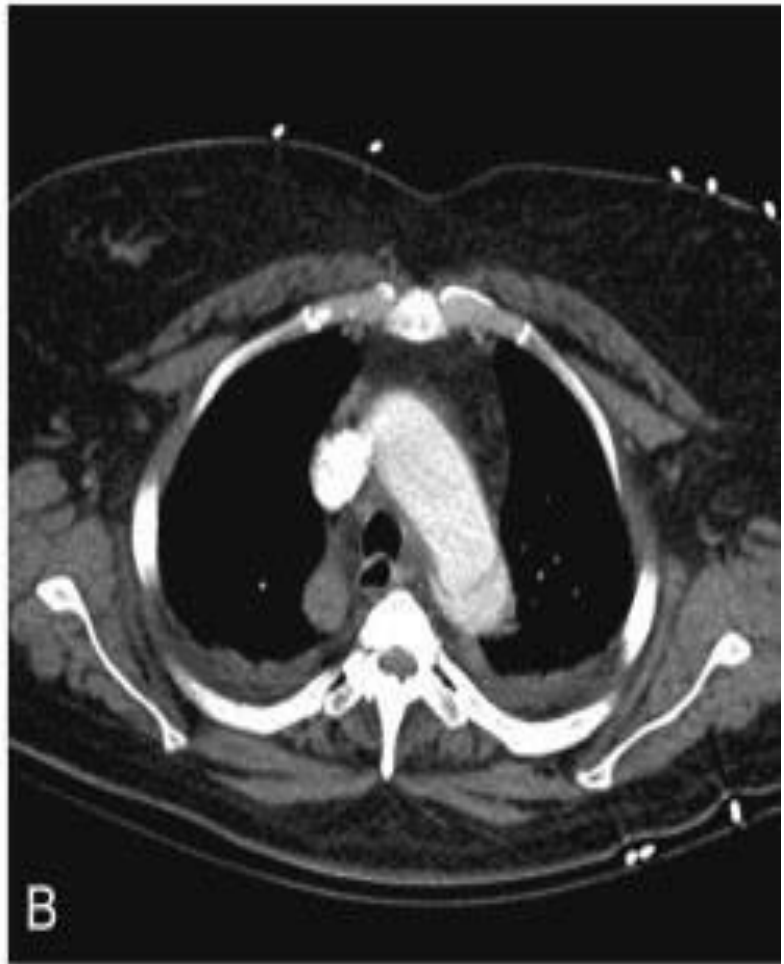
Noise(CT)

Noise in computed tomography is an unwanted change in [pixel](#) values in an otherwise homogeneous image. Often noise is defined loosely as the grainy appearance on [cross-sectional imaging](#).

Noise in a cross-sectional image will equal a decrease in the picture quality and inadvertently will hinder the contrast resolution.

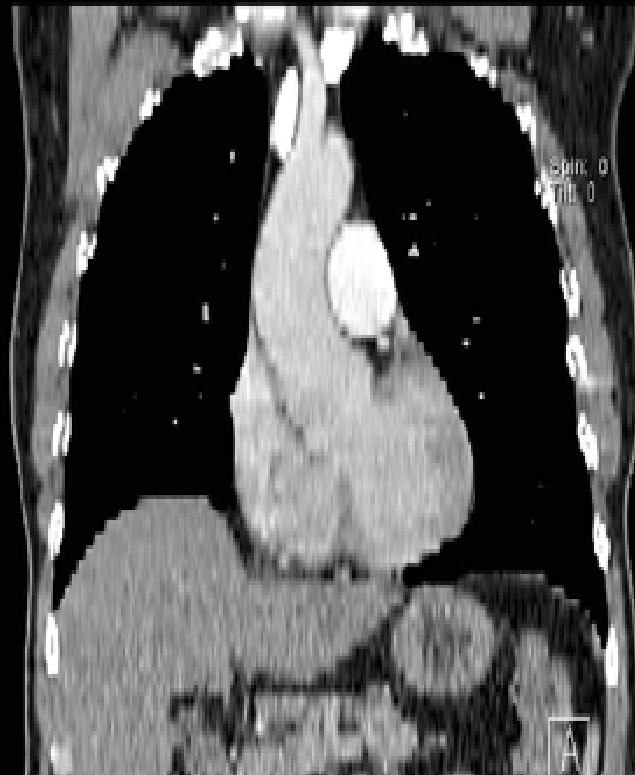
Normal

Aliasing

Aliasing artifact, known as **undersampling**, in CT refers to an error in the accuracy proportion of analog to digital converter (ADC) during image digitization.

The more samples that are taken the more accurate the representation of the signal will be, hence if a lack of sampling has occurred the computer will process an inaccurate image resulting in an aliasing artifact.

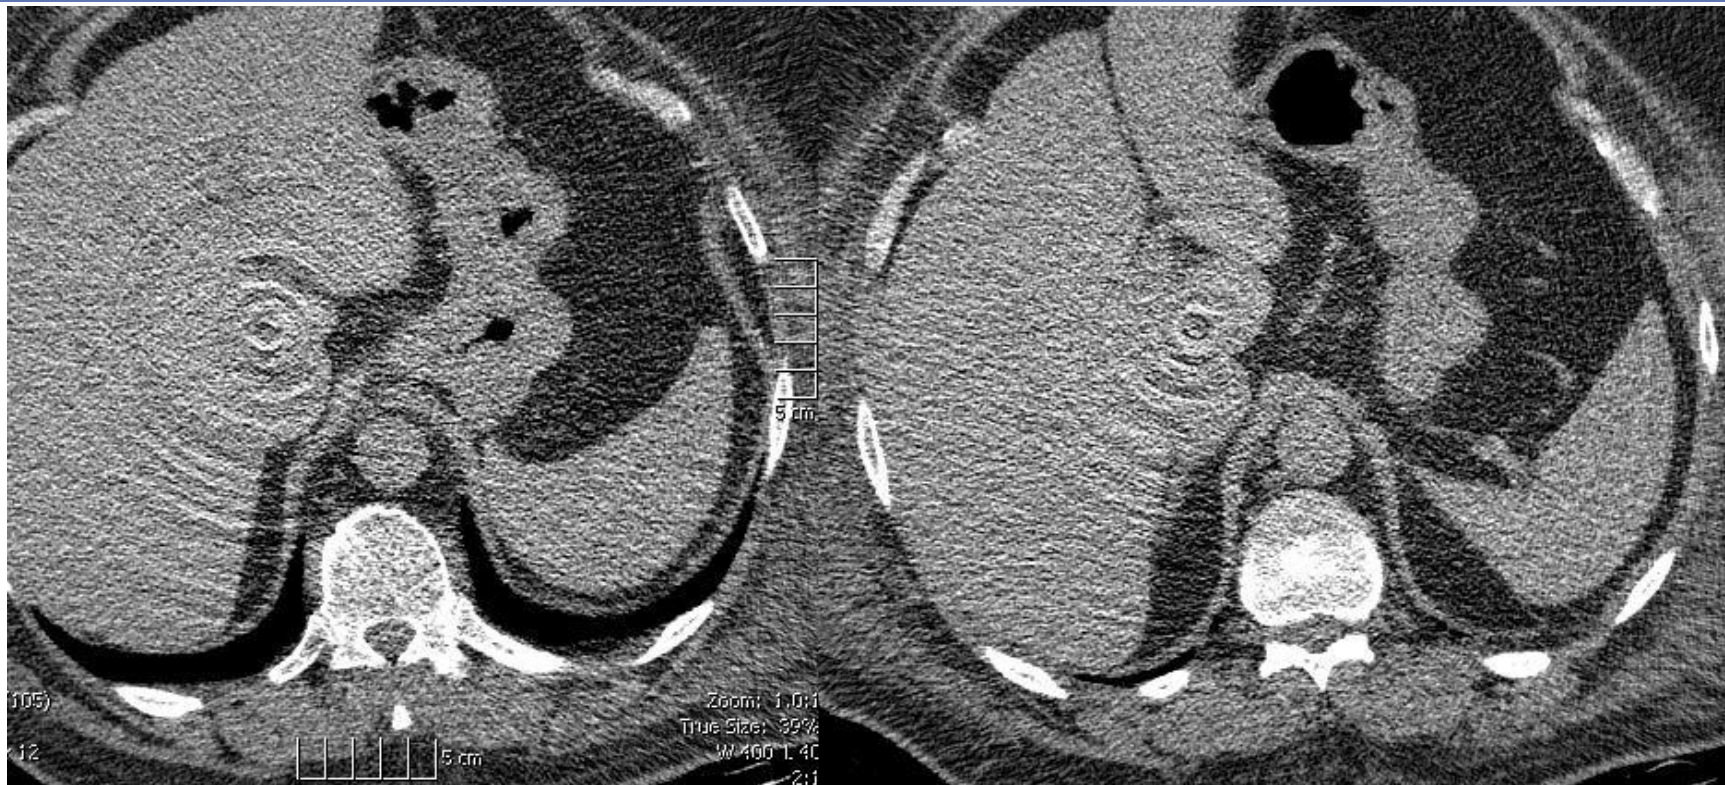
Ring artifact

Ring artifacts are a CT phenomenon that occurs due to miscalibration or failure of one or more detector elements in a CT scanner

They occur close to the isocenter of the scan and are usually visible on multiple slices at the same location. They are a common problem in cranial CT.

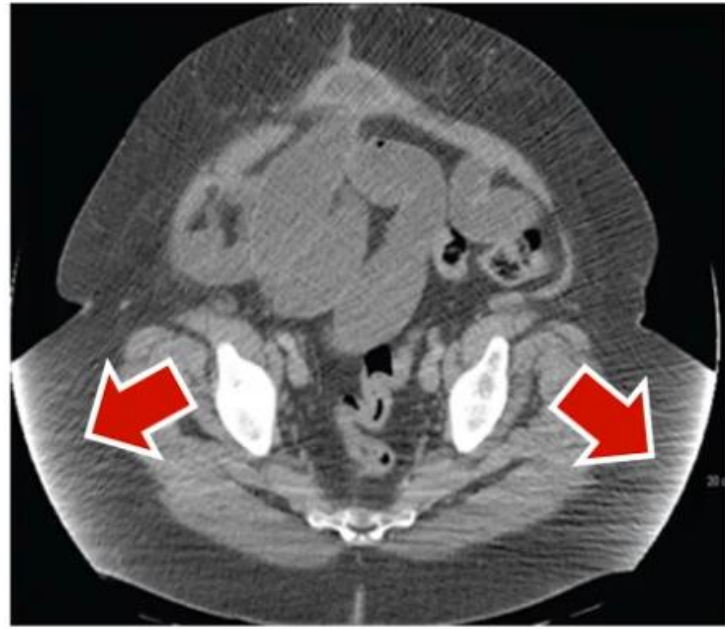
OUT-OF-FIELD ARTIFACT

Out of field artifact (also known as **incomplete projection artifact**) is due to part of the patient existing peripheral to the field of view of the CT scanner. This can be a particular issue in obese patients who only just fit within the scanner bore.

The lack of data from these out of field tissue/objects interferes with the ability of the software to generate a correct image leading to streaking, and areas of unusual increased or decreased density.

- *Caused by parts of patient outside of SFOV*
- *Appears bright areas on the edges of the images*

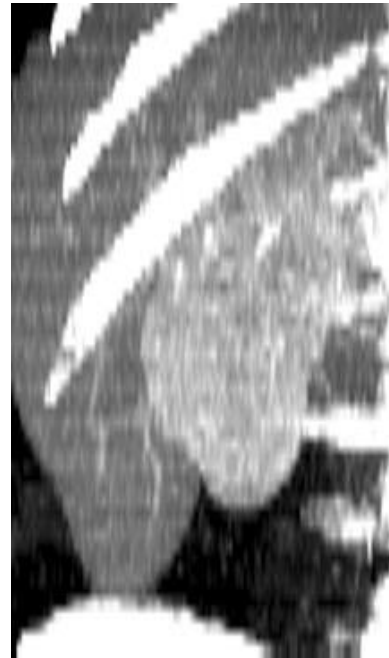
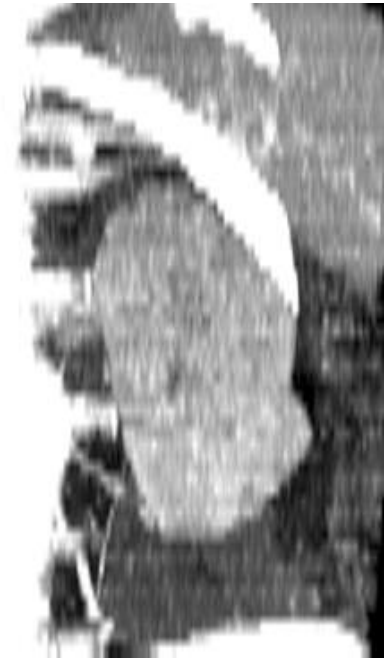
Zebra stripes/artifacts

appear as alternating bright and dark bands in a MRI image.

In CT there is also a zebra artifact from 3D reconstructions and a zebra sign from hemorrhage in the cerebellar sulci .

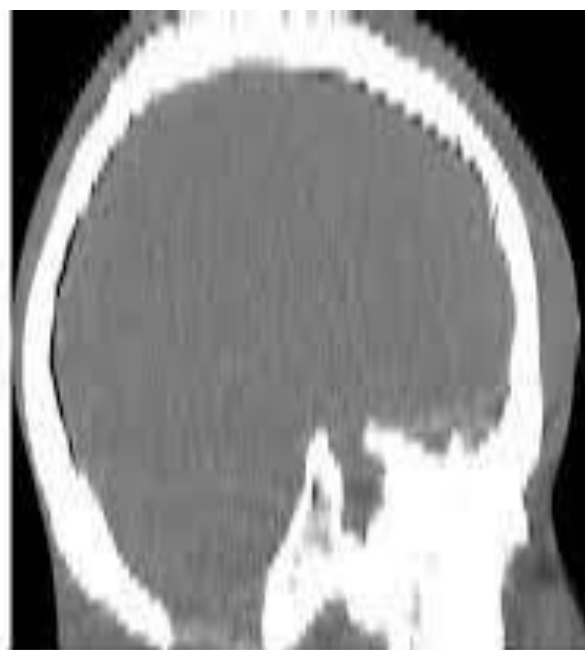
CT stair-step artifact

The **CT stair-step artifact** is found in straight structures which are oriented obliquely with respect to movement of the table and appear around the edges of sagittal and coronal reformatted images when wide collimations and non-overlapping reconstruction intervals are used.

It is also seen in [coronary CT angiography](#) when step-wise reconstructions are from different cardiac phases. This is associated with heart rate variability and irregular heart rates.
