Magnetic Resonance Imaging

First Semester Lecture 9: Artifacts and their compensation

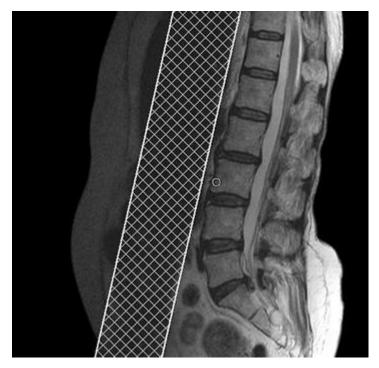
Fig. 2: Image showing saturation band anterior to the spine.

-Saturation Band It is also called REST slab or SAT band and is used to suppress the signal from a part of the FOV (Fig. 2). A 90 degrees RF pulse is sent immediately prior to proper sequence tilting the magnetization in transverse plane in the region of the band. When proper excitation pulse follows there is no longitudinal magnetization in this region to be tilted. Hence this region will not have any signal.

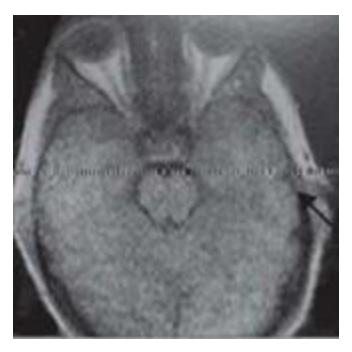
Fig 7: Zipper artifact

This artifact is caused by external RF entering the room at a certain frequency and interfering with inherently weak signal coming from the patient. There are various causes for zipper artifacts in images. Most of them are related to hardware or software problems. The zipper artifacts that can be controlled easily are those due to RF entering the scanning room when the door is open during acquisition of images. RF from radio transmitters will cause zipper artifacts that are oriented perpendicular to the frequency axis of the image. Fig.7

-Axis: Perpendicular to the frequency axis of the image.
