**College of Health and Medical
Technologies
Department of Radiology
Technologies
Computed Tomography**

CT ARTIFACTS

LECTUER 8

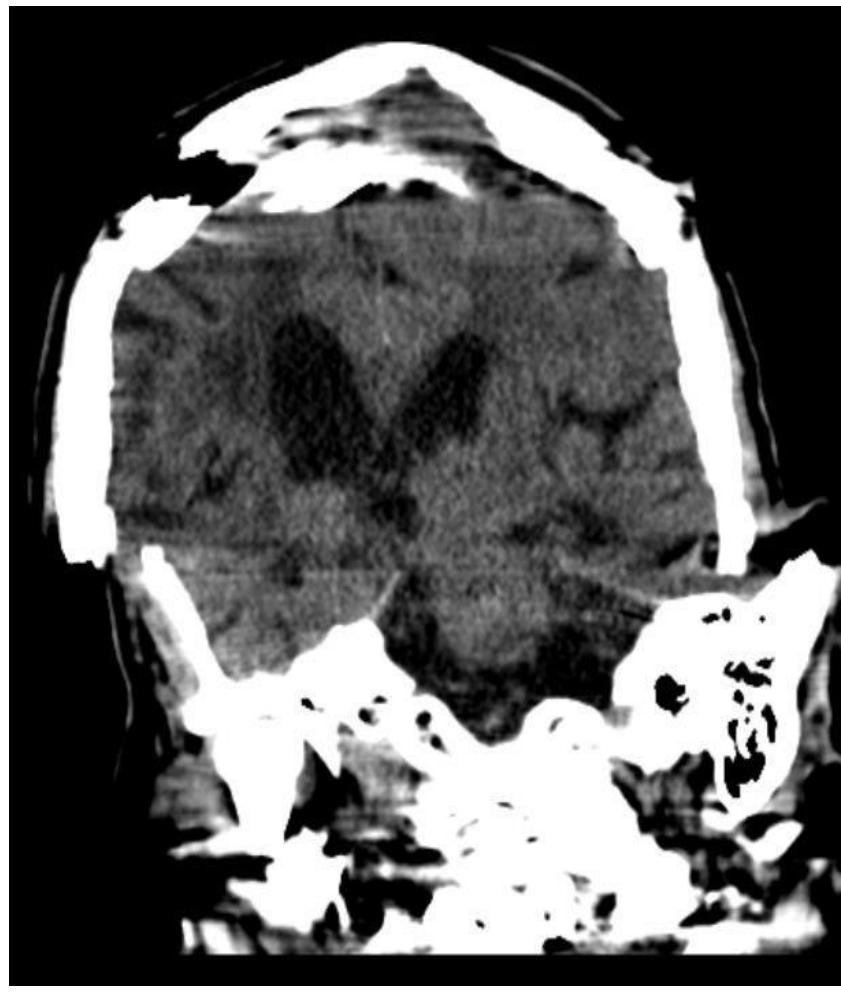
Misregistration artifacts, which appear as blurring, streaking, or shading, are caused by patient movement during a CT scan. Blurring also occurs with patient movement during radiographic examinations.

Involuntary motion, such as respiration or cardiac motion, may cause artifacts that mimic pathology in surrounding structures. Techniques, such as cardiac gating, may be used for examinations that concern the mediastinum

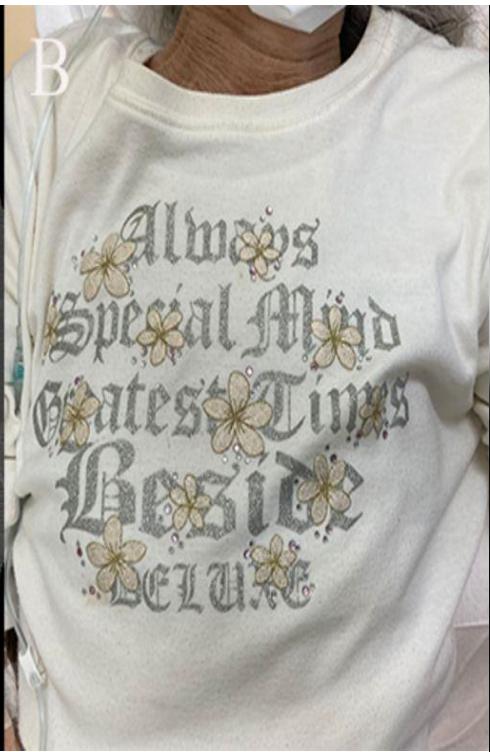
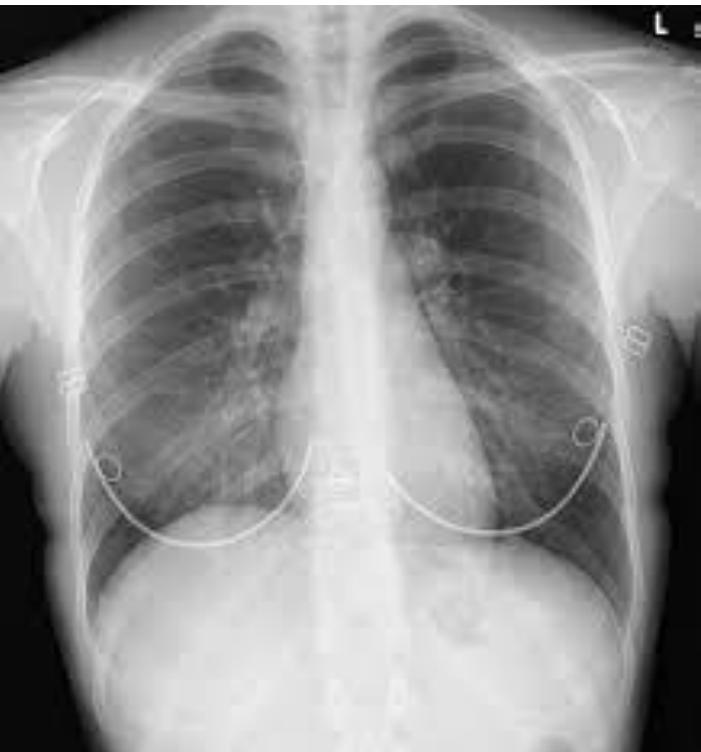
Clothing artifacts

Clothing artifacts, like [jewelry artifacts](#), are a regular feature on imaging examinations, especially [plain radiographs](#), but in general are recognized for what they are, either at the time the image is taken by the radiographer, or later by the reporting radiologist. The radiographer will often either retake the image or more commonly they will label the image with a warning that clothing artifact is present to avoid any misinterpretation taking place.

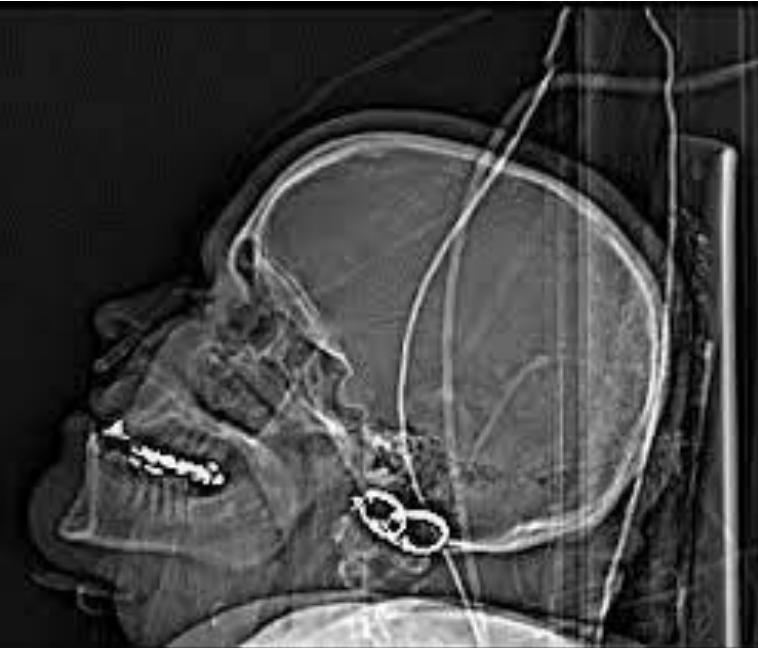
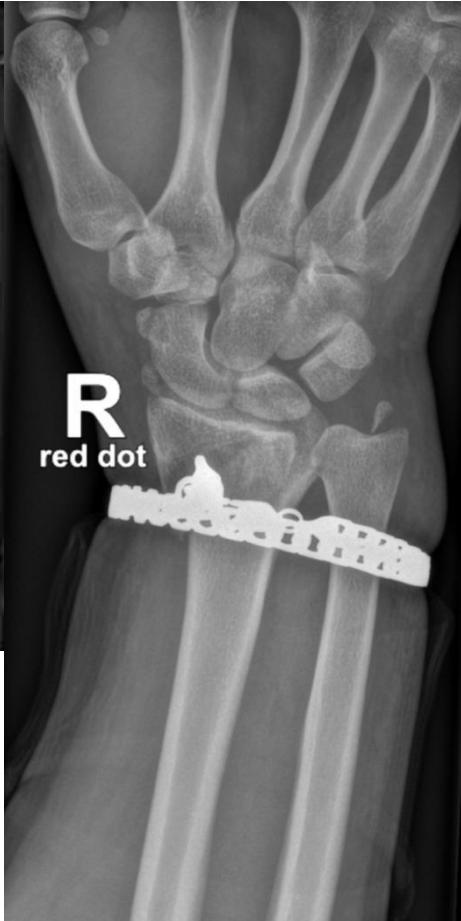
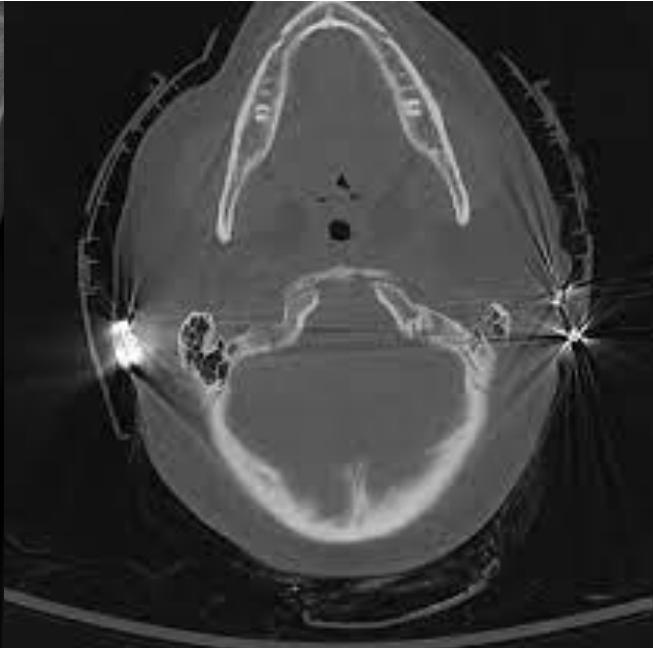
jewelry artifacts

It is common to see **jewelry artifacts** on imaging examinations, most commonly plain radiographs, although also on other modalities, where they can produce unhelpful artifacts that may obscure important structures and preclude confident diagnostic evaluation

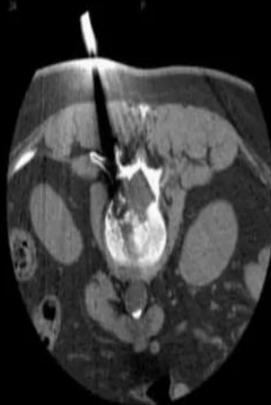
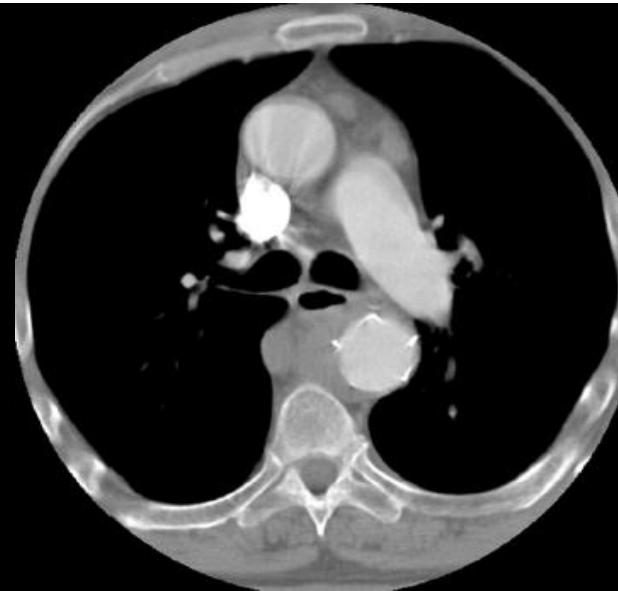
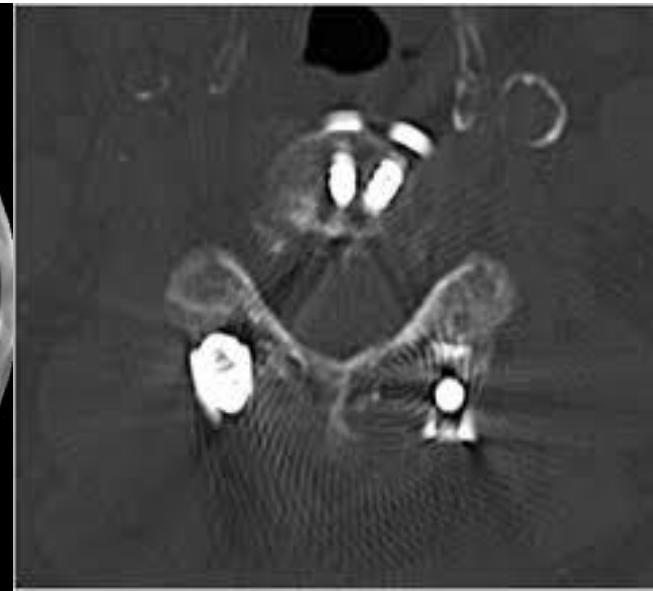
Streaking artifact appears as multiple dark streaking bands positioned between two dense objects, for example at the posterior fossa. Streaking may also occur along the long axis of a single high attenuation object. It is the result of the polychromatic x-ray being hardened' at different rates according to rotational position of the tube/detector.

Shading from missing data in shadow of biopsy needle.

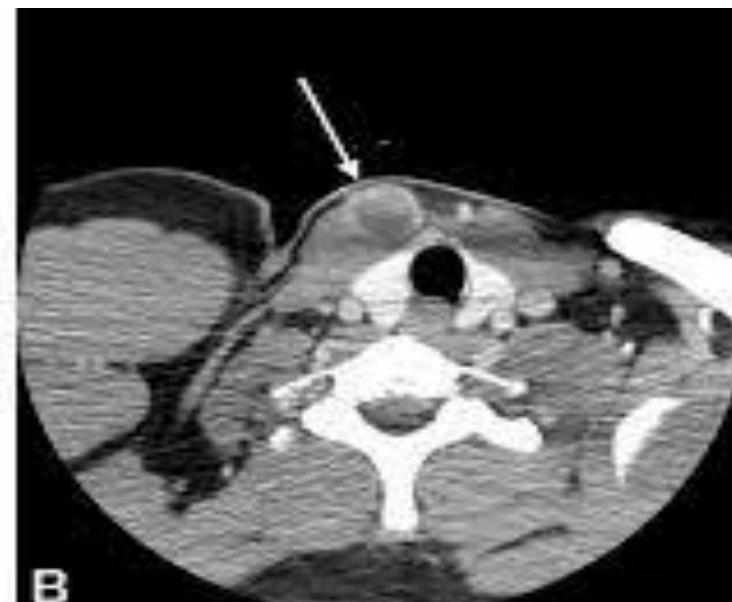
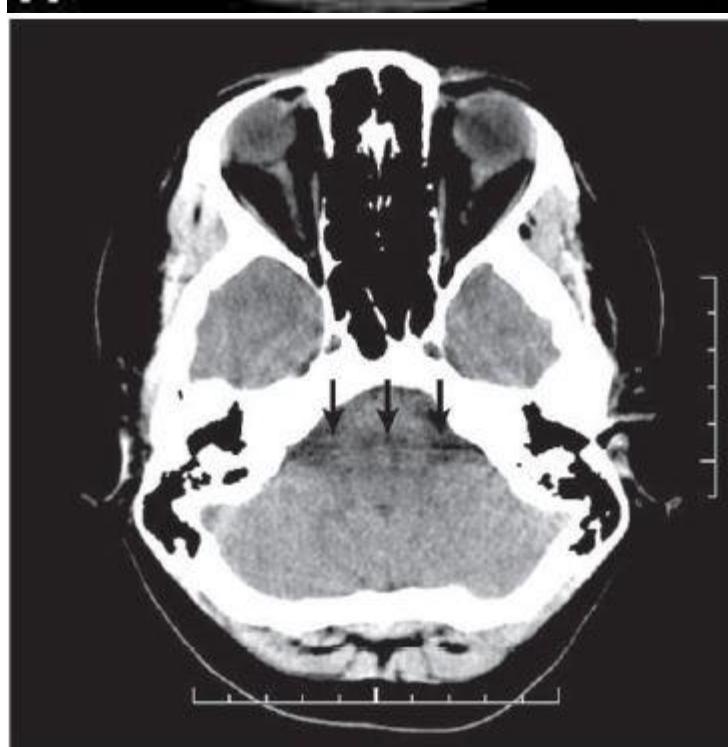
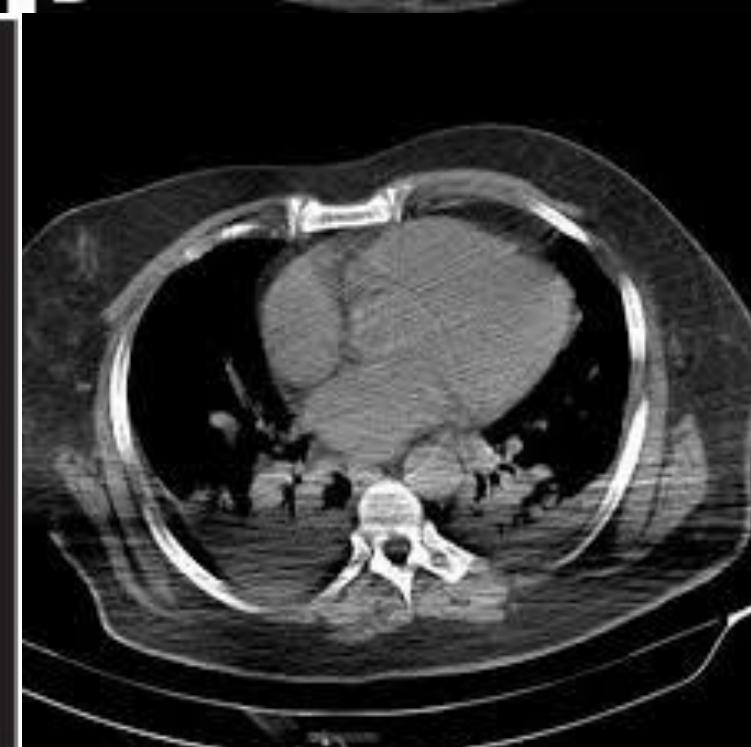
Beam hardening

is the phenomenon that occurs when an x-ray beam comprised of polychromatic energies passes through an object, resulting in selective attenuation of lower energy photons. The effect is conceptually similar to a high-pass filter, in that only higher energy photons are left to contribute to the beam and thus the mean beam energy is increased ("hardened")

CT beam hardening artifact has two distinct manifestations, streaking (dark bands) and cupping artifacts.

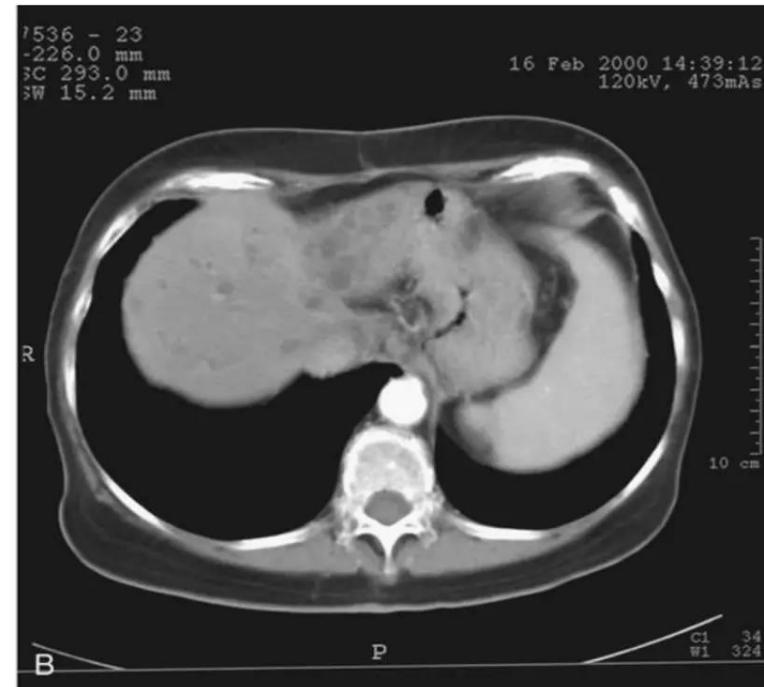
PARTIAL VOLUME ARTEFACT

Liver scan showing partial-volume artifact. A, A 2.5-mm slice thickness shows good visibility of small liver lesions. B, A 10-mm slice thickness shows reduced lesion detectability with partial-volume averaging. (Images courtesy Dr. John Haaga.)

occurs when tissues of widely different absorption are encompassed on the same CT [voxel](#) producing a beam attenuation proportional to the average value of these tissues.

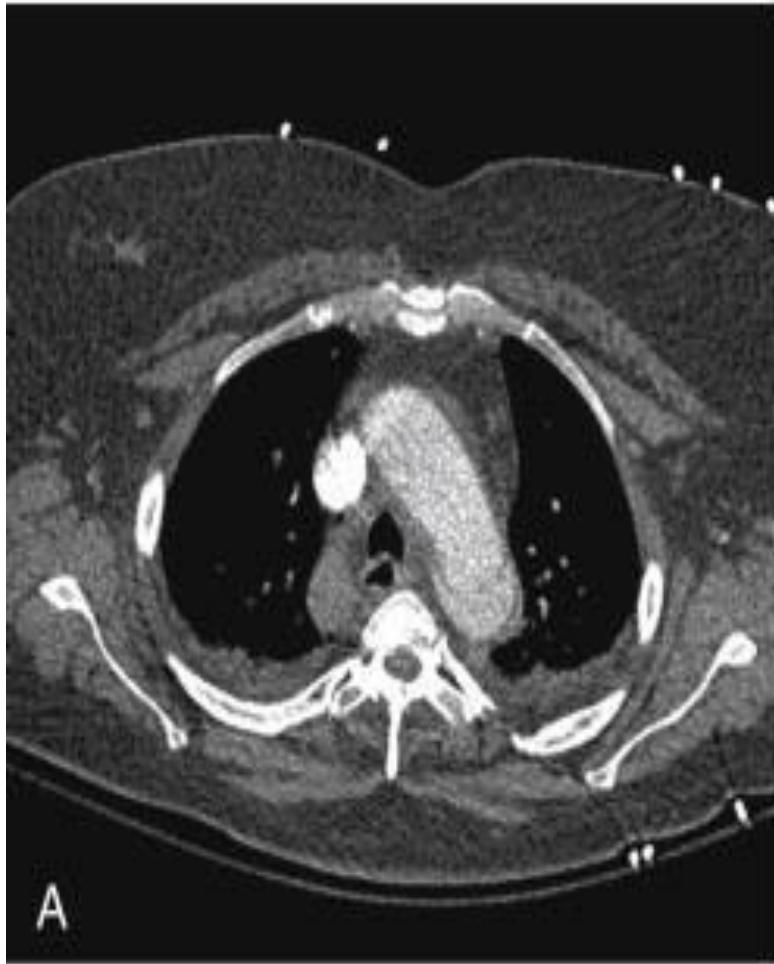
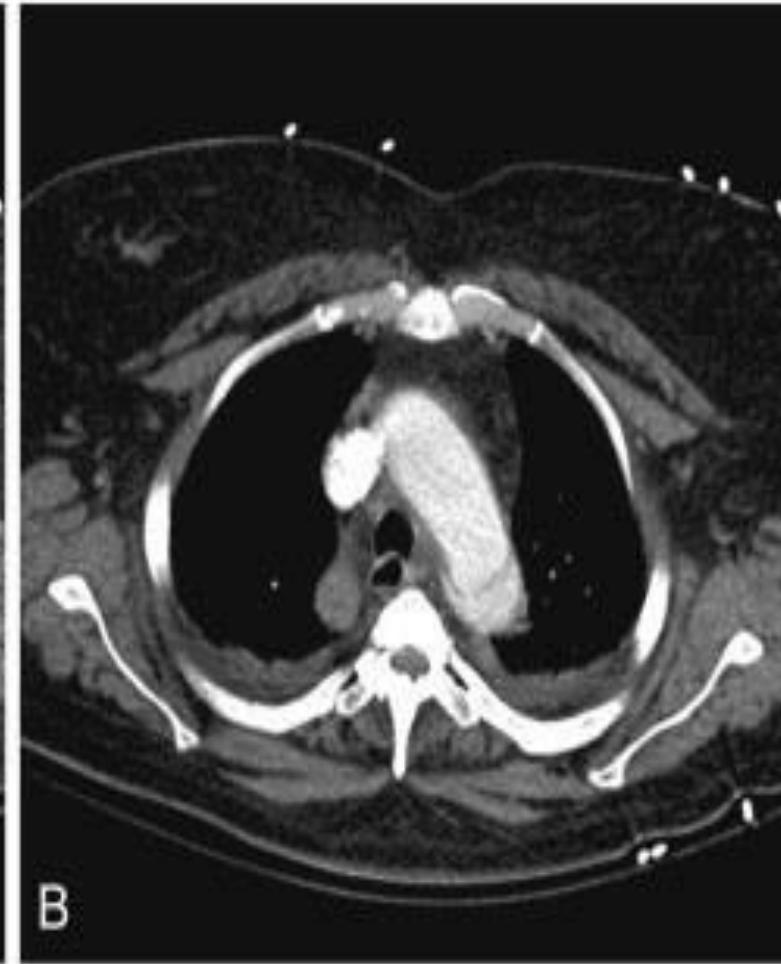
Noise(CT)

Noise in computed tomography is an unwanted change in pixel values in an otherwise homogeneous image. Often noise is defined loosely as the grainy appearance on cross-sectional imaging.

Noise in a cross-sectional image will equal a decrease in the picture quality and inadvertently will hinder the contrast resolution.

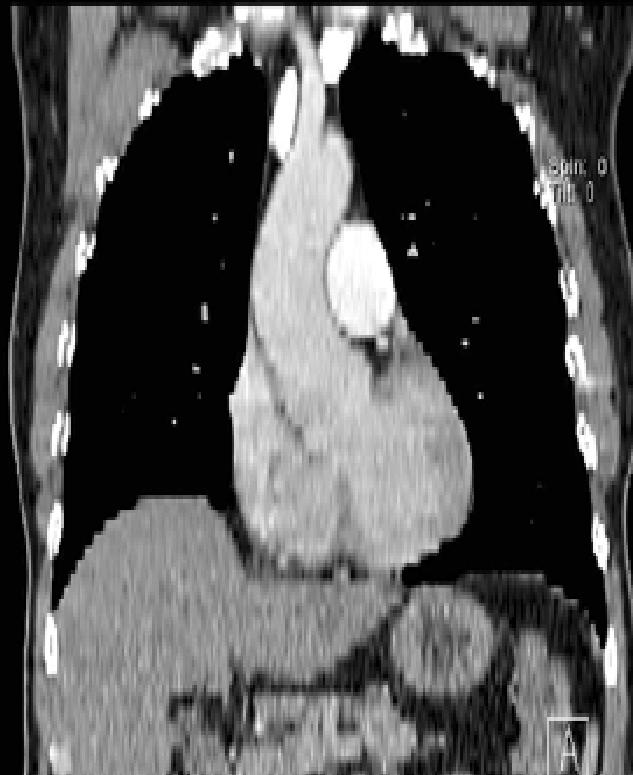
The more samples that are taken the more accurate the representation of the signal will be, hence if a lack of sampling has occurred the computer will process an inaccurate image resulting in an aliasing artifact.

Normal

Aliasing

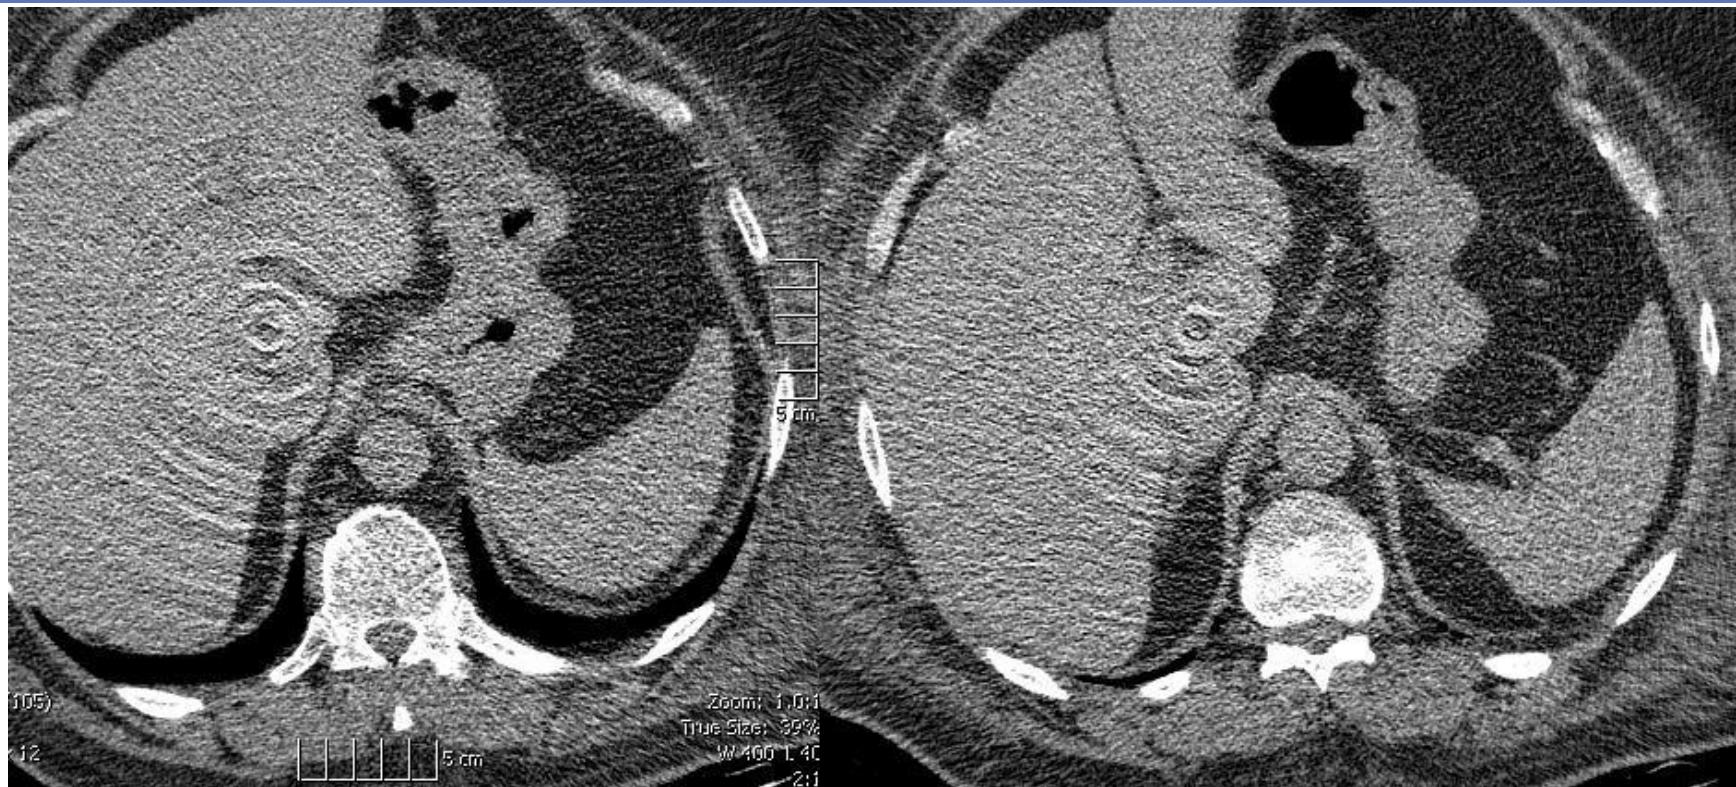
Ring artifact

Ring artifacts are a CT phenomenon that occurs due to miscalibration or failure of one or more detector elements in a CT scanner

They occur close to the isocenter of the scan and are usually visible on multiple slices at the same location. They are a common problem in cranial CT.

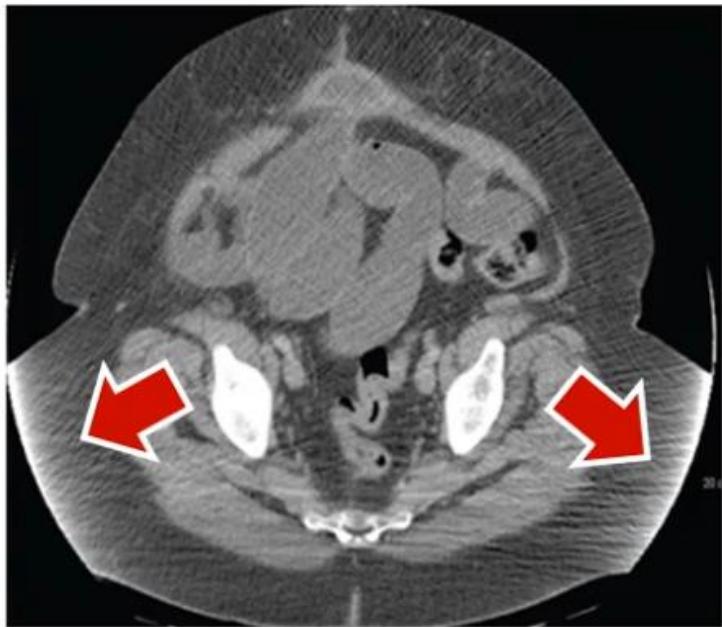
OUT-OF-FIELD ARTIFACT

- *Caused by parts of patient outside of SFOV*
- *Appears bright areas on the edges of the images*

Out of field artifact (also known as **incomplete projection artifact**) is due to part of the patient existing peripheral to the field of view of the CT scanner. This can be a particular issue in obese patients who only just fit within the scanner bore.

The lack of data from these out of field tissue/objects interferes with the ability of the software to generate a correct image leading to streaking, and areas of unusual increased or decreased density.

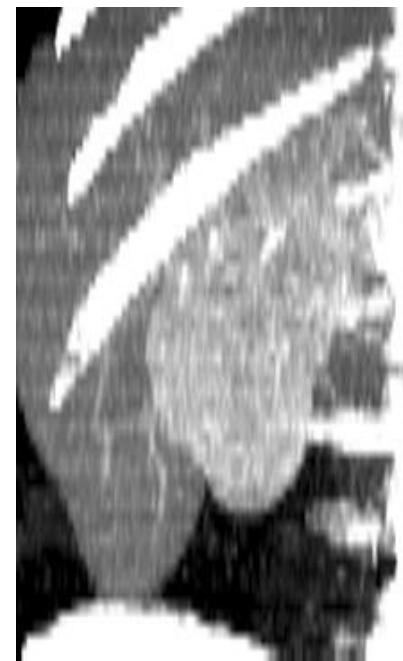
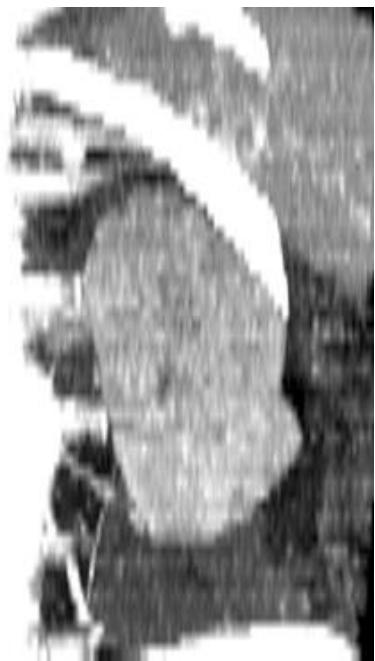
Zebra stripes/artifacts

appear as alternating bright and dark bands in a MRI image.

In CT there is also a zebra artifact from 3D reconstructions and a zebra sign from hemorrhage in the cerebellar sulci .

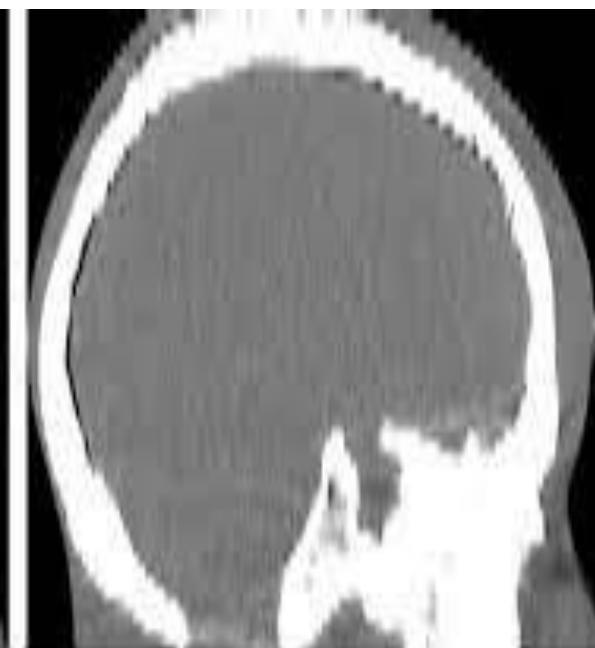
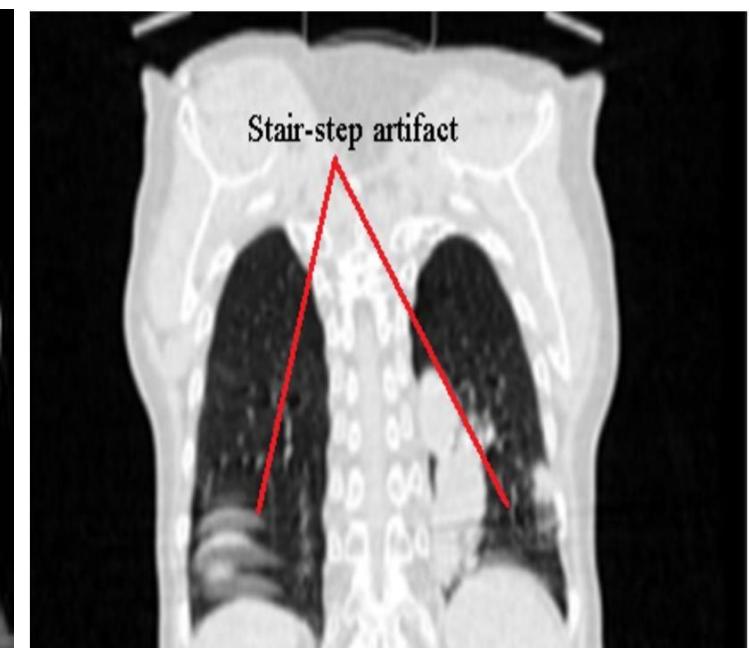
CT stair-step artifact

The **CT stair-step artifact** is found in straight structures which are oriented obliquely with respect to movement of the table and appear around the edges of sagittal and coronal reformatted images when wide collimations and non-overlapping reconstruction intervals are used.

It is also seen in [coronary CT angiography](#) when step-wise reconstructions are from different cardiac phases. This is associated with heart rate variability and irregular heart rates.
