## **Causes of X-ray Tube Failure**

### **COMMON FAULTS, THEIR CAUSES & REMEDY**

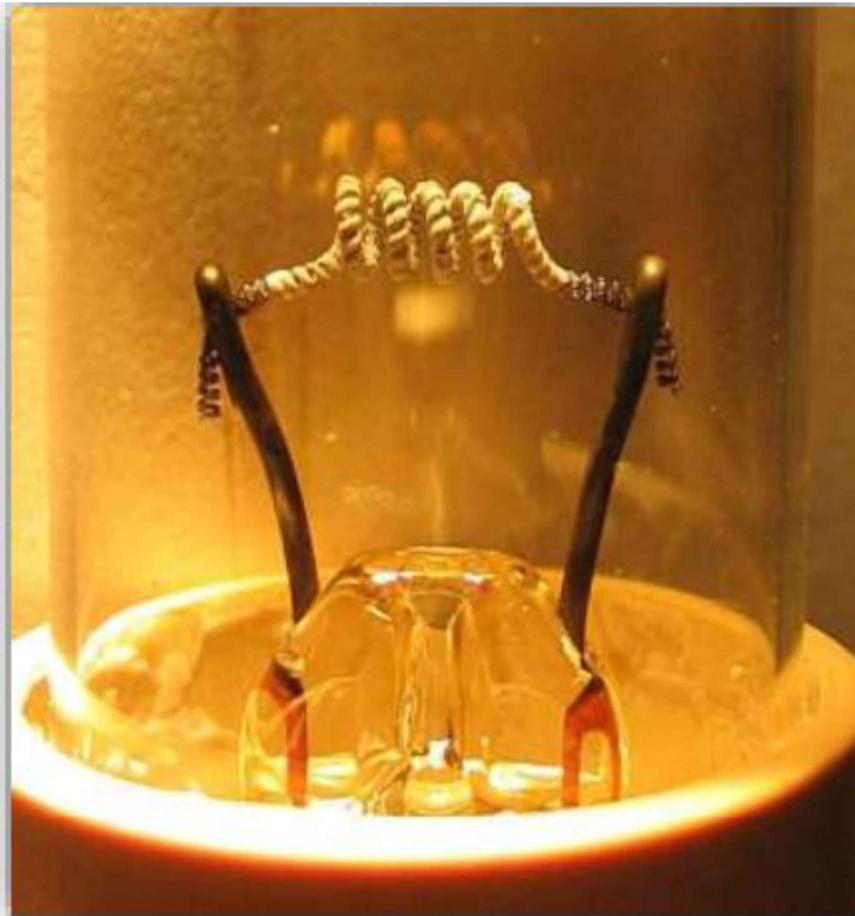
### **4. FAULTS IN FILAMENT (Vaporization of filament).**

Excessive heating of filament for the longer period of time.

The vaporization of filament or breakage of filament lead to no exposure takes place.

Use of 1-2 % Thorium with tungsten filament.

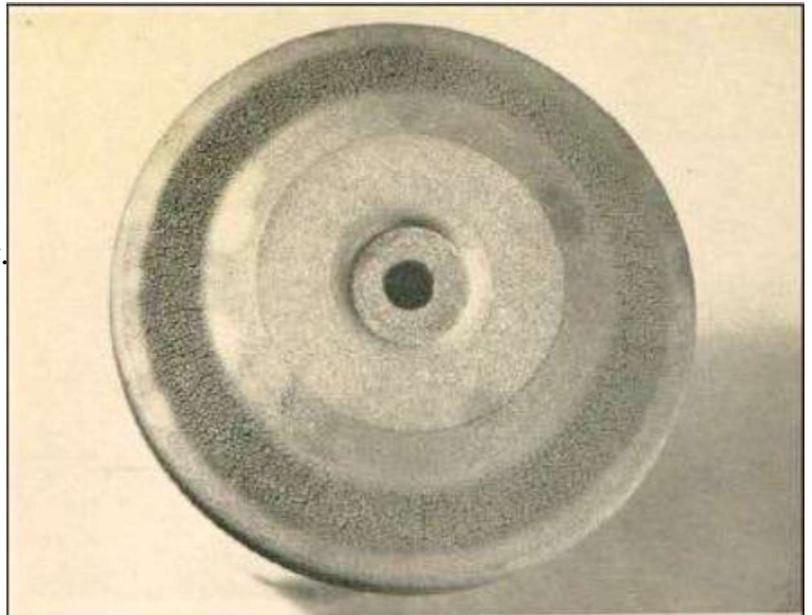
### **B. Roughening and pitting of anode surface**

Excessive thermal stress.

- Scattering of the x-rays
- Absorption of x-rays by the target itself.
- Results in diminish x-ray output.

- Use of lowest necessary power
- Largest possible focal spot
- Longer exposures at reduced power.

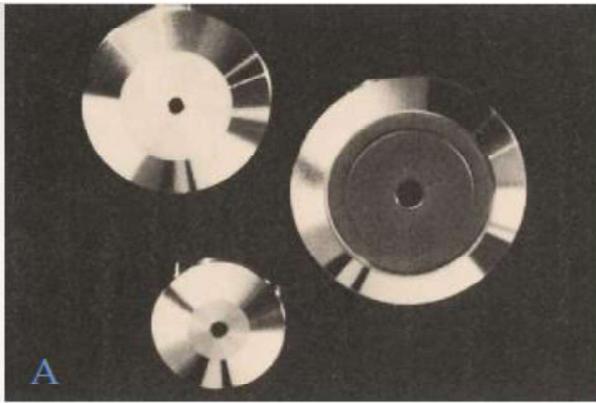
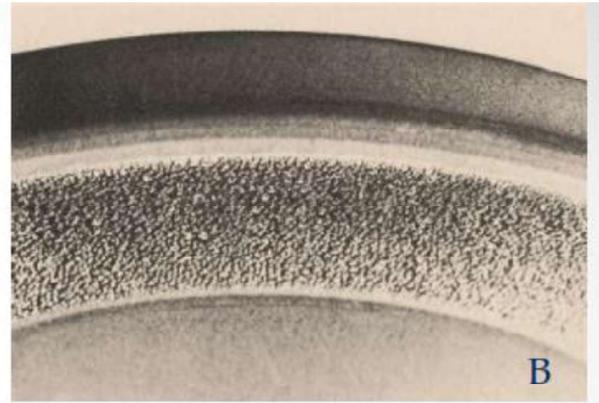
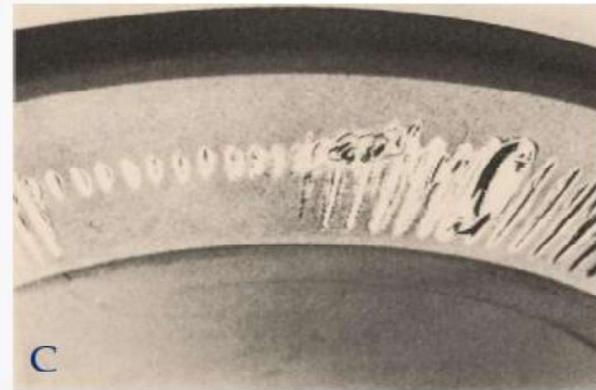
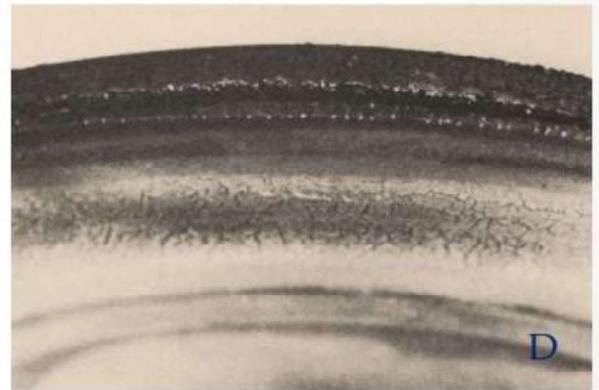
Comparison of smooth, shiny appearances of rotating anodes when new (A) versus their appearance after failure (B,C,D).

#### **Cause**

#### **Results**
