**Al-Mustaqlal University
College of Health and Medical Technologies
Radiological Techniques Department**

Magnetic Resonance Imaging

**First Semester
Lecture 4: MRI artifact during the
exam : Types, Remedies**

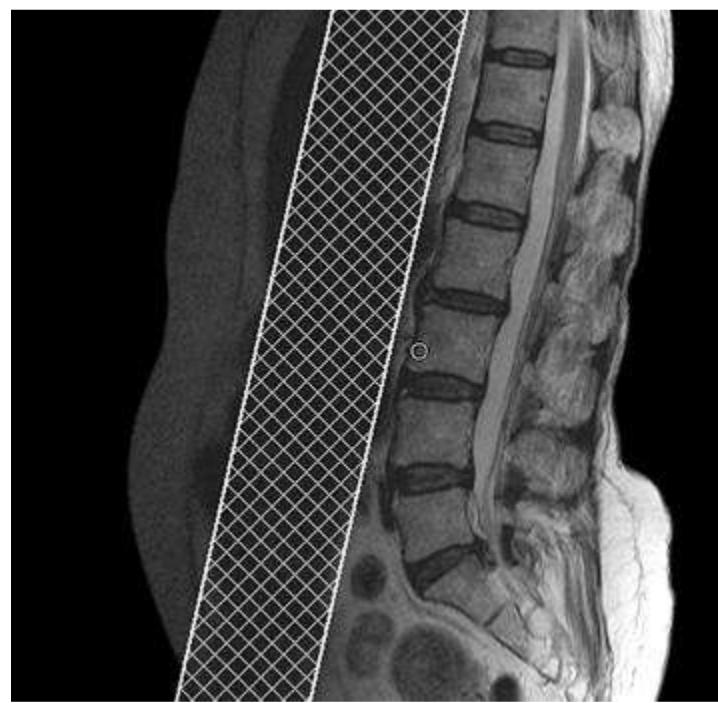
Fig. 2: Image showing saturation band anterior to the spine.

-Saturation Band It is also called REST slab or SAT band and is used to suppress the signal from a part of the FOV (Fig. 2). A 90 degrees RF pulse is sent immediately prior to proper sequence tilting the magnetization in transverse plane in the region of the band. When proper excitation pulse follows there is no longitudinal magnetization in this region to be tilted. Hence this region will not have any signal.

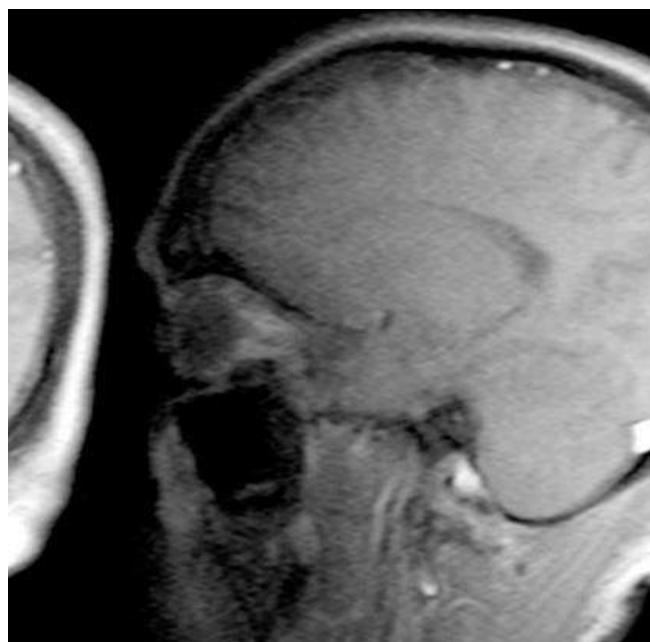
Fig 3: Aliasing artifact

In aliasing, anatomy that exists outside the FOV appears within the image and on the opposite side (Fig. 3). When the imaging field of view is smaller than the anatomy being imaged, aliasing occurs.

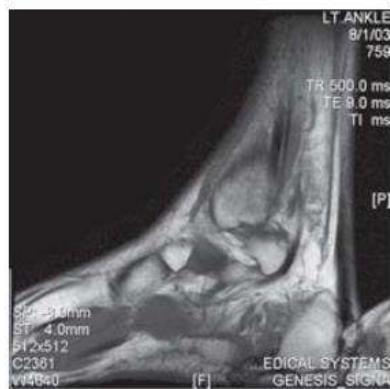
Fig. 7.3: Back folding artifact

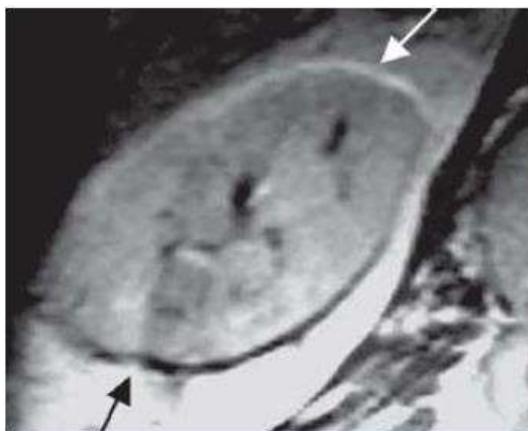
Fig. 7.6: Chemical shift mis-registration artifact water in the kidneys is misregistered along the frequency axis. This causes black signal (arrow) voids at the kidneys left margins and white lines at their right margin (arrow)

Chemical shift artifacts appear at **the interfaces between water and fat because the precessional frequency of protons is slightly different in these two substances**. This leads to misregistration of the signals. They are displayed by the equipment as **dark region of signal void on one side of water containing tissue and a region of bright signal at the other end of the water fat interface due to super imposition of fat and water signals on the frequency encoding direction**.

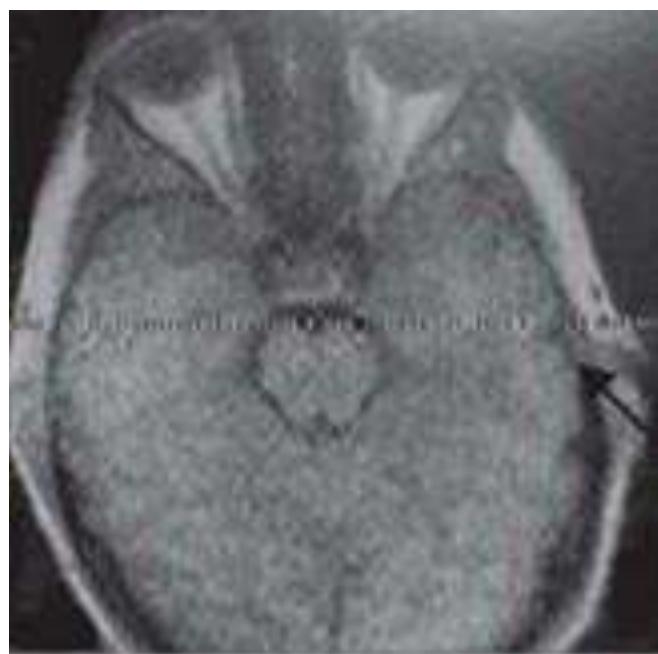
Fig 7: Zipper artifact

This artifact is caused by external RF entering the room at a certain frequency and interfering with inherently weak signal coming from the patient. There are various causes for zipper artifacts in images. Most of **them are related to hardware or software problems**. The zipper artifacts that can be controlled easily are those due to RF entering the scanning room when the door is open during acquisition of images. RF from radio transmitters will cause zipper artifacts that are oriented perpendicular to the frequency axis of the image. Fig.7
